INVENTORY FORM FOR STATE HISTORIC SITES SURVEY

Riley Farm

1.4 miles south of Bozman on Leadenham Creek, on Cooper Point Road

HISTORIC SITES SURVEY FIELD SHEET
Individual Structure Survey Form

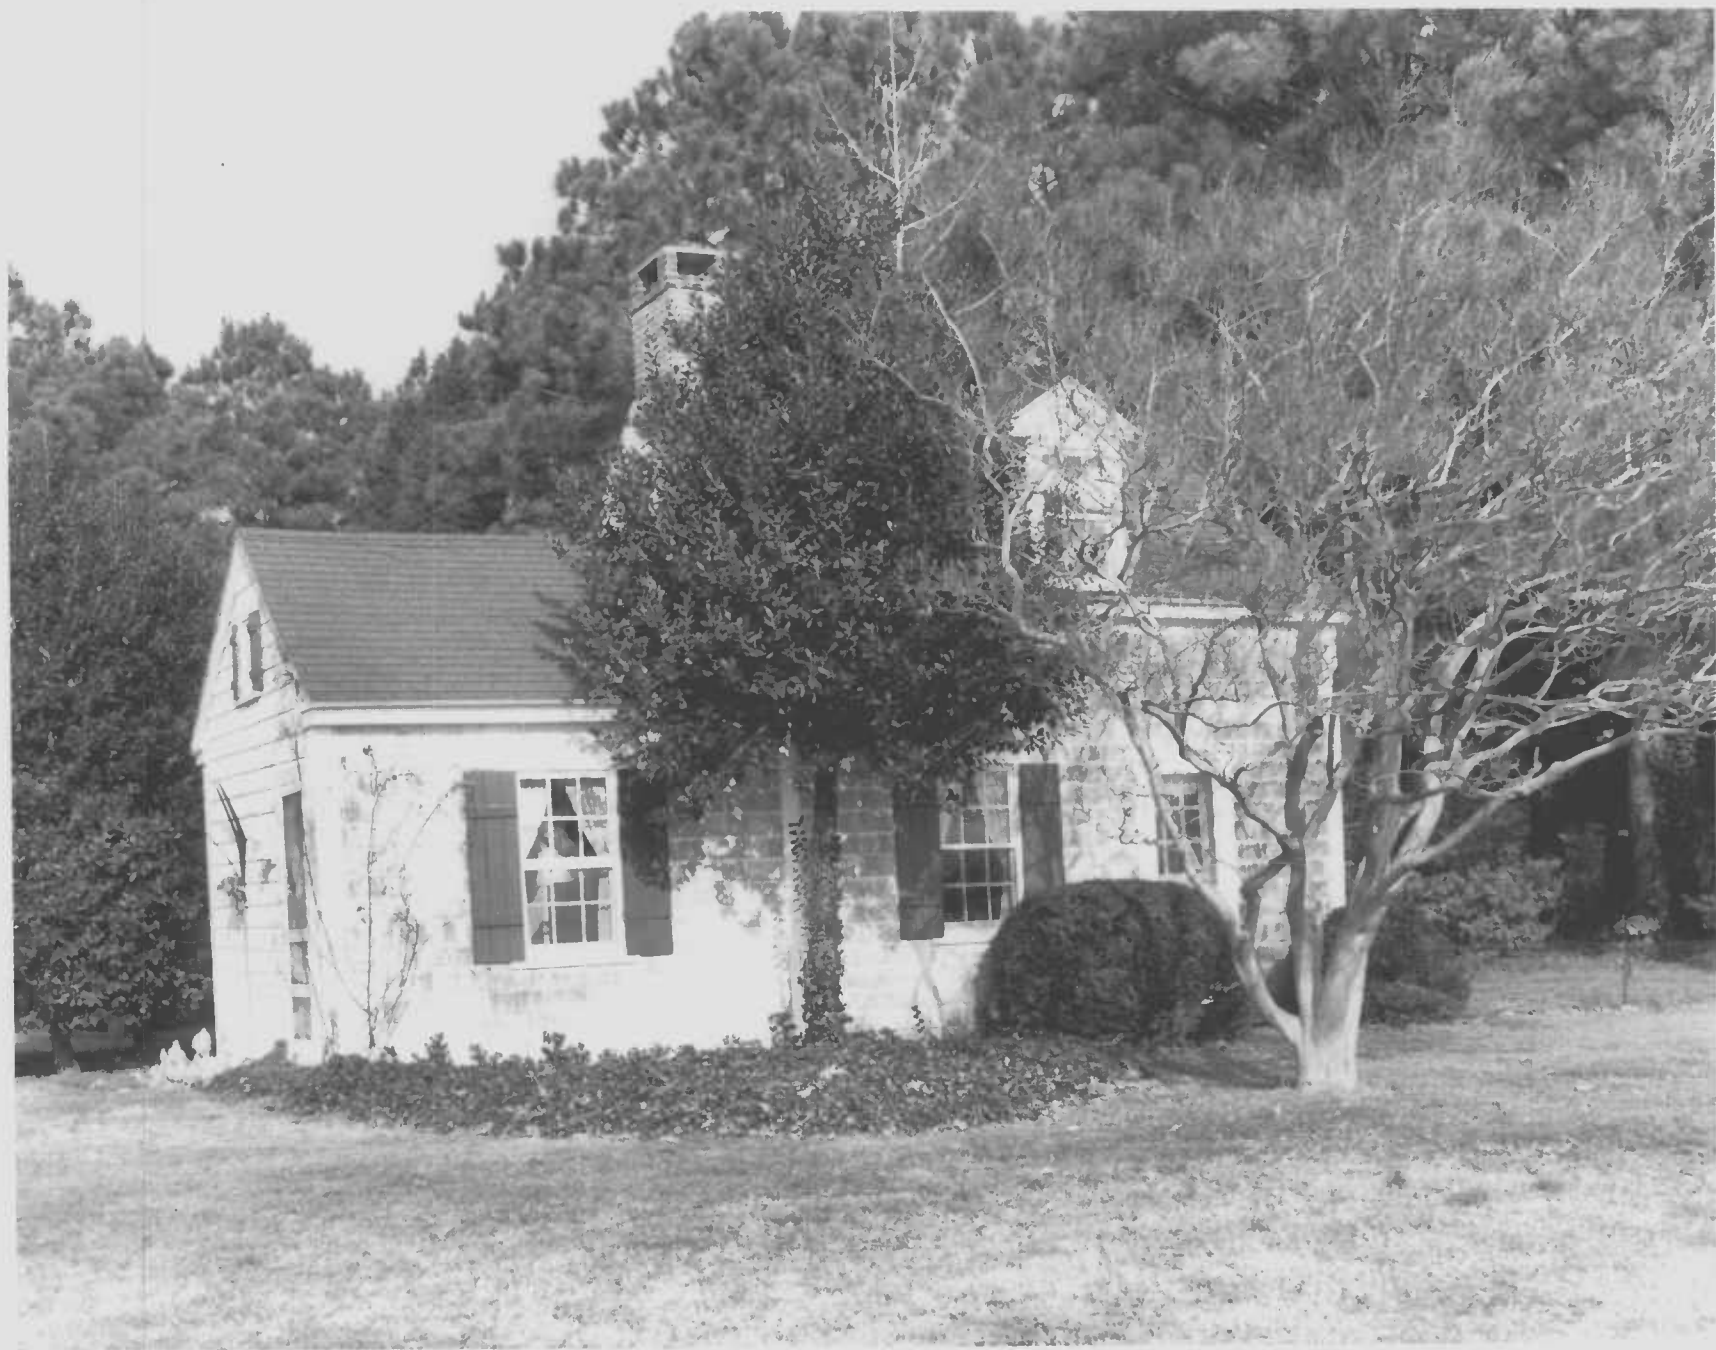
T-221

waterside view

p. 6 Mt. Mans #15

Cooper Point Road

Broad Creek side

Home of Mr. & Mrs. John Montgomery - 1889

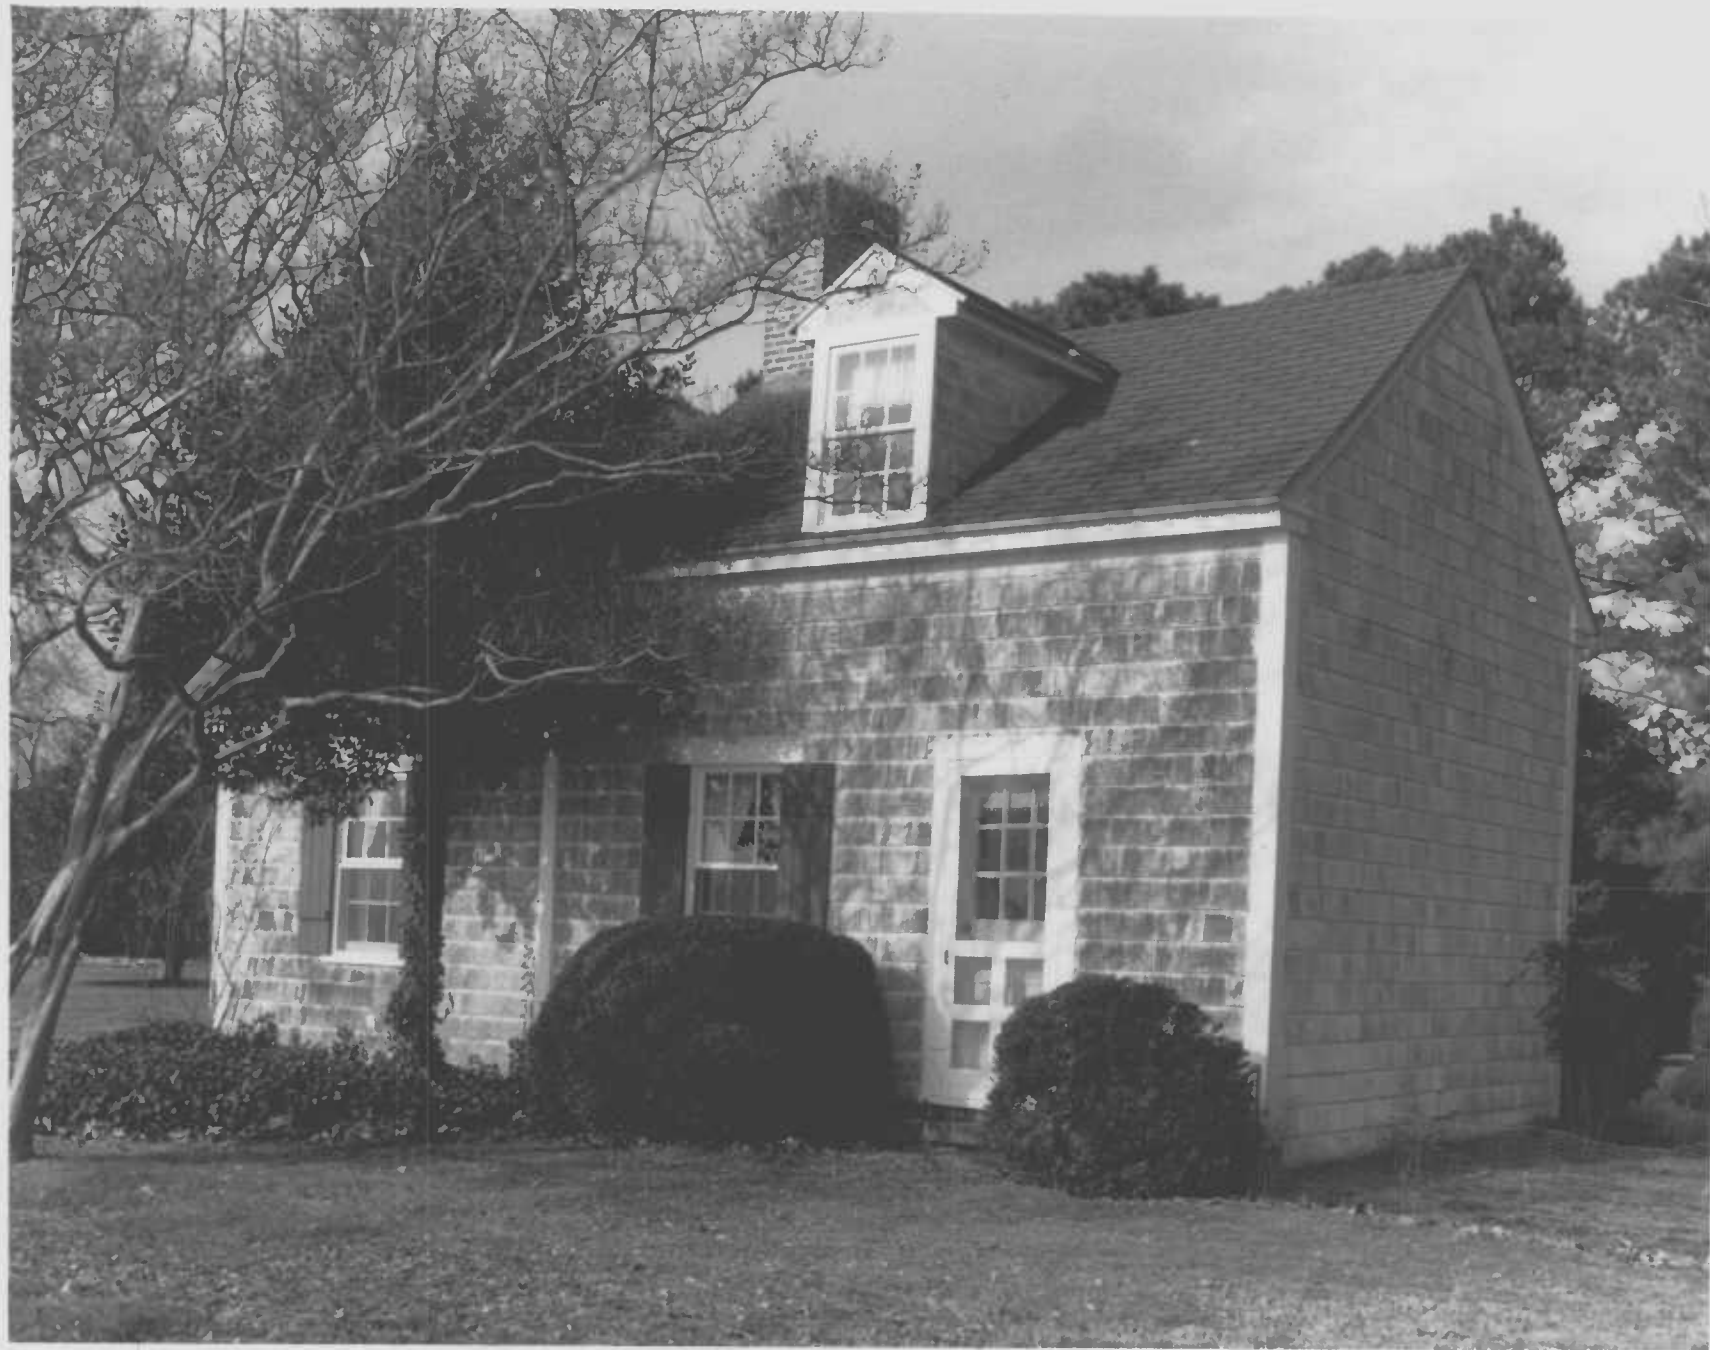
T-221

p. 6 MHT Map. # (15)

Cooper Point Road,
Broad Creek side.

Home of Mr. + Mrs. John Montgomery - 1989
